# **INTERNAL CURING OF CONCRETE PAVING: LABORATORY AND FIELD EXPERIENCE**

**Synopsis:** The construction of a five-mile section of State Highway (SH) 121 north of Dallas is currently underway by the Texas Department of Transportation (TxDOT) and involves the conversion of a non-freeway into a freeway facility. This technical paper presents the field experience for mixing, placing, finishing, and testing of slipform mainline concrete paving, utilizing rotary kiln expanded lightweight aggregate as both an intermediate gradation and as reservoir to provide water to enhance the cement hydration of a typical paving mix. There is abundant laboratory research on internal curing of concrete including but not limited to numerous studies by Bentz et al “Internal Curing and Microstructure of High Performance Mortars”. Construction of SH 121 represents the next logical step, following research, taking the laboratory to the field in the form of this major highway project. TxDOT anticipates higher strengths, leading to reduced paste content, reduced drying shrinkage cracking, and possibly less susceptibility to freeze thaw damage.

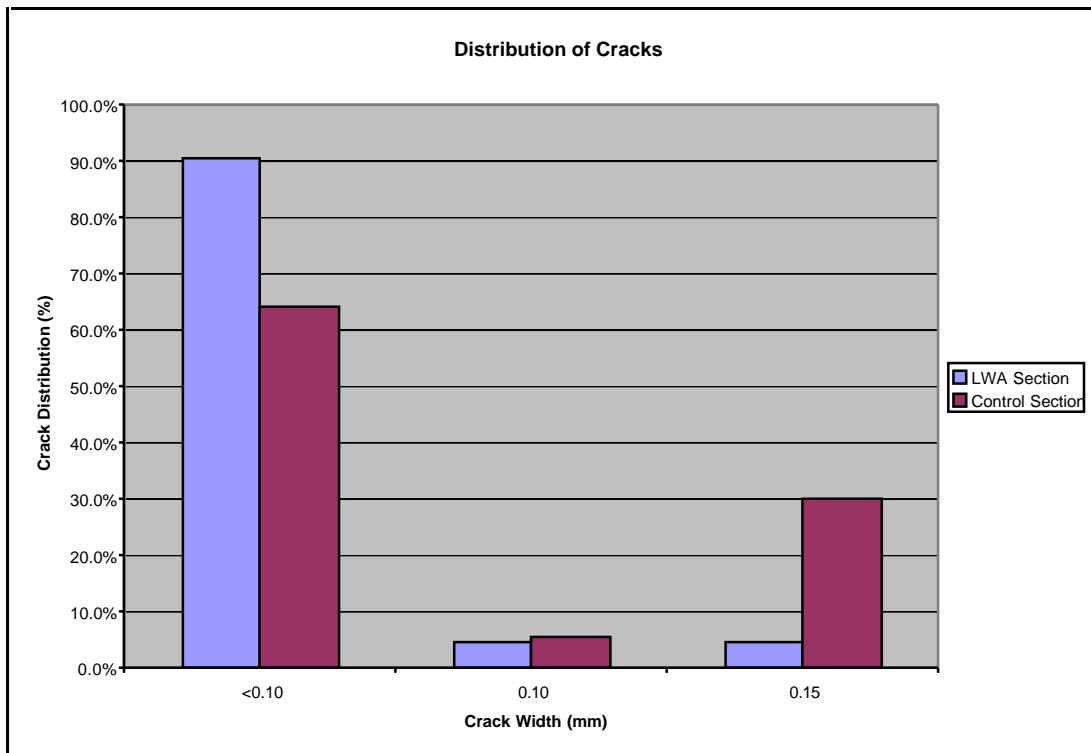
**Figure 11 - Crack distributions on lightweight aggregate and control section**

On September 11, 2007, an additional crack survey was conducted by the Transtec Group (TG). During this inspection, both the test section and an adjacent pavement section placed with the contractor's standard mix were measured and compared for quantity and width of cracks. There is an overwhelming reduction in the number of cracks (21 vs. 52) and a significant reduction in the measured width of the cracks between the standard mix and the test section (90% vs. 63% less than 0.10mm).
